The Performance of CFRP Strengthening During a Real Fire

Tim Stratford
Jian-fei Chen
Martin Gillie

The University of Edinburgh

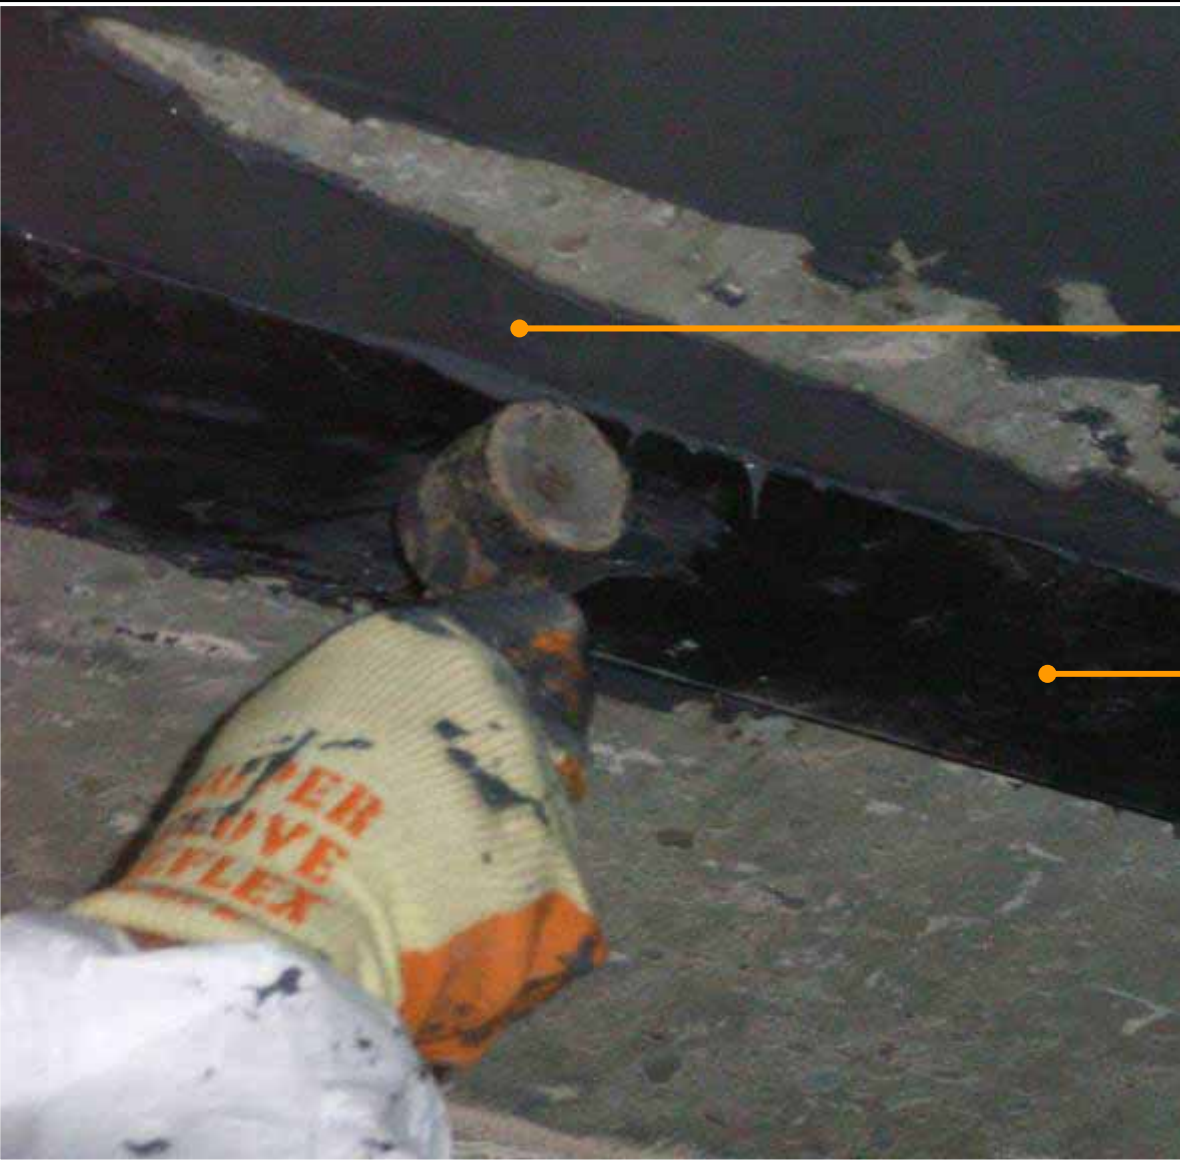
Bonding adhesive
 $T_g \approx 65$ to 100°C (?)

Preformed CFRP plate
 T_g of resin $\approx 250^\circ\text{C}$ (?)

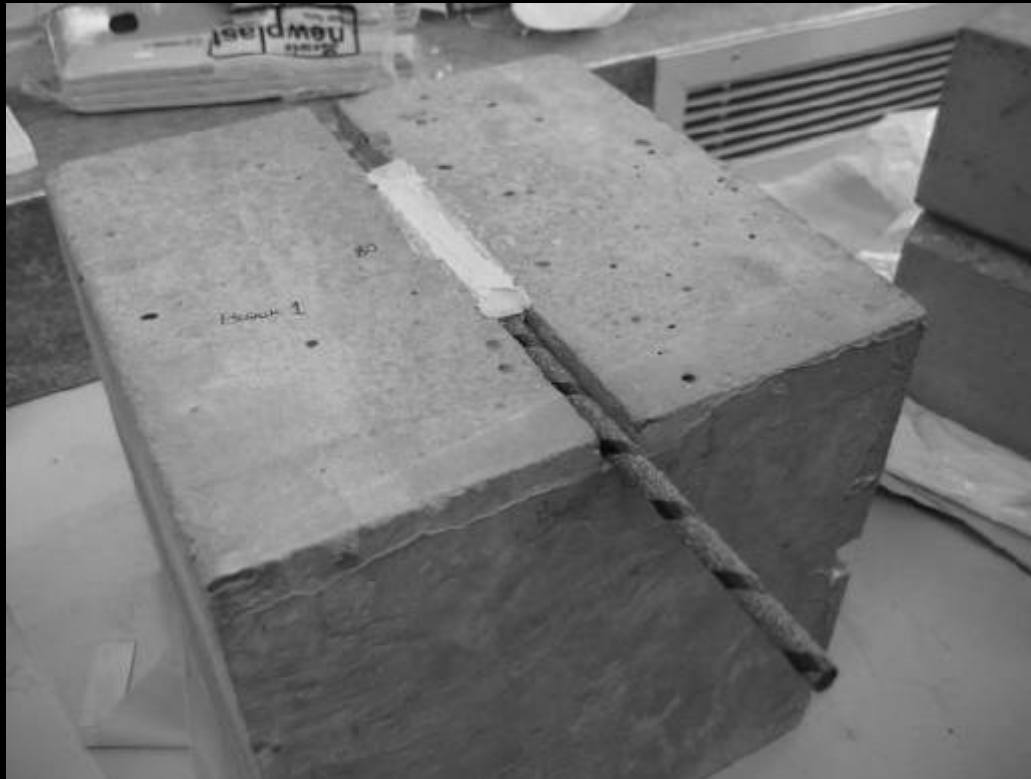
Installation – NSM FRP

Near-surface mounted FRP strengthening:
bonded into a groove cut into the concrete soffit
Industry perception: better fire performance.

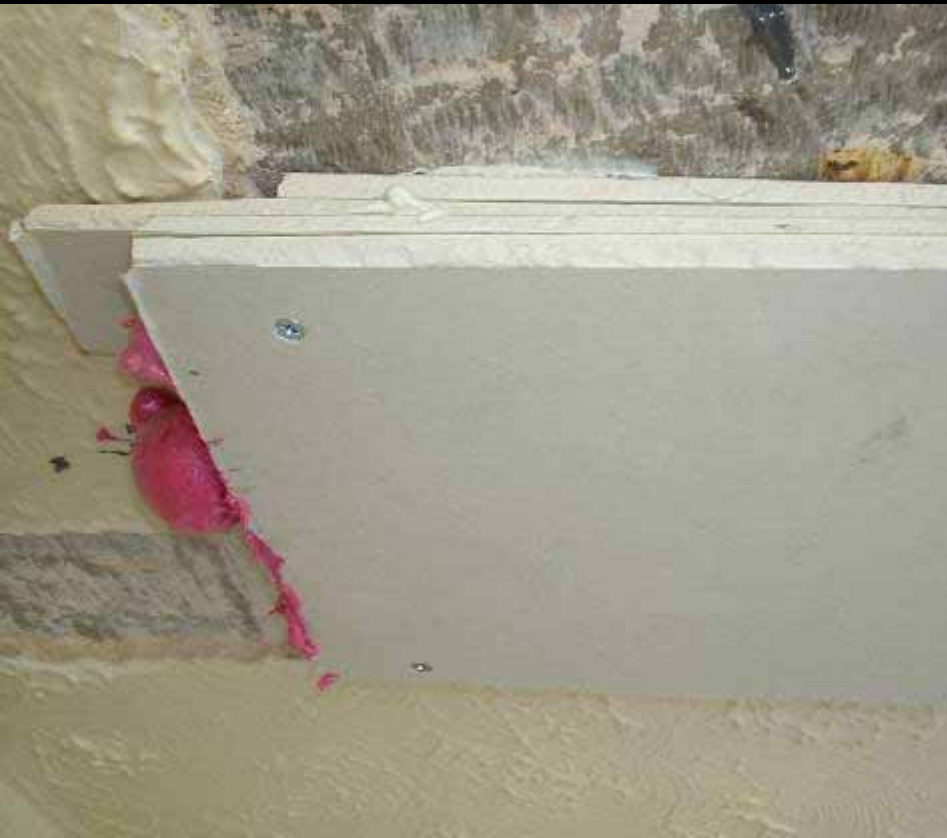
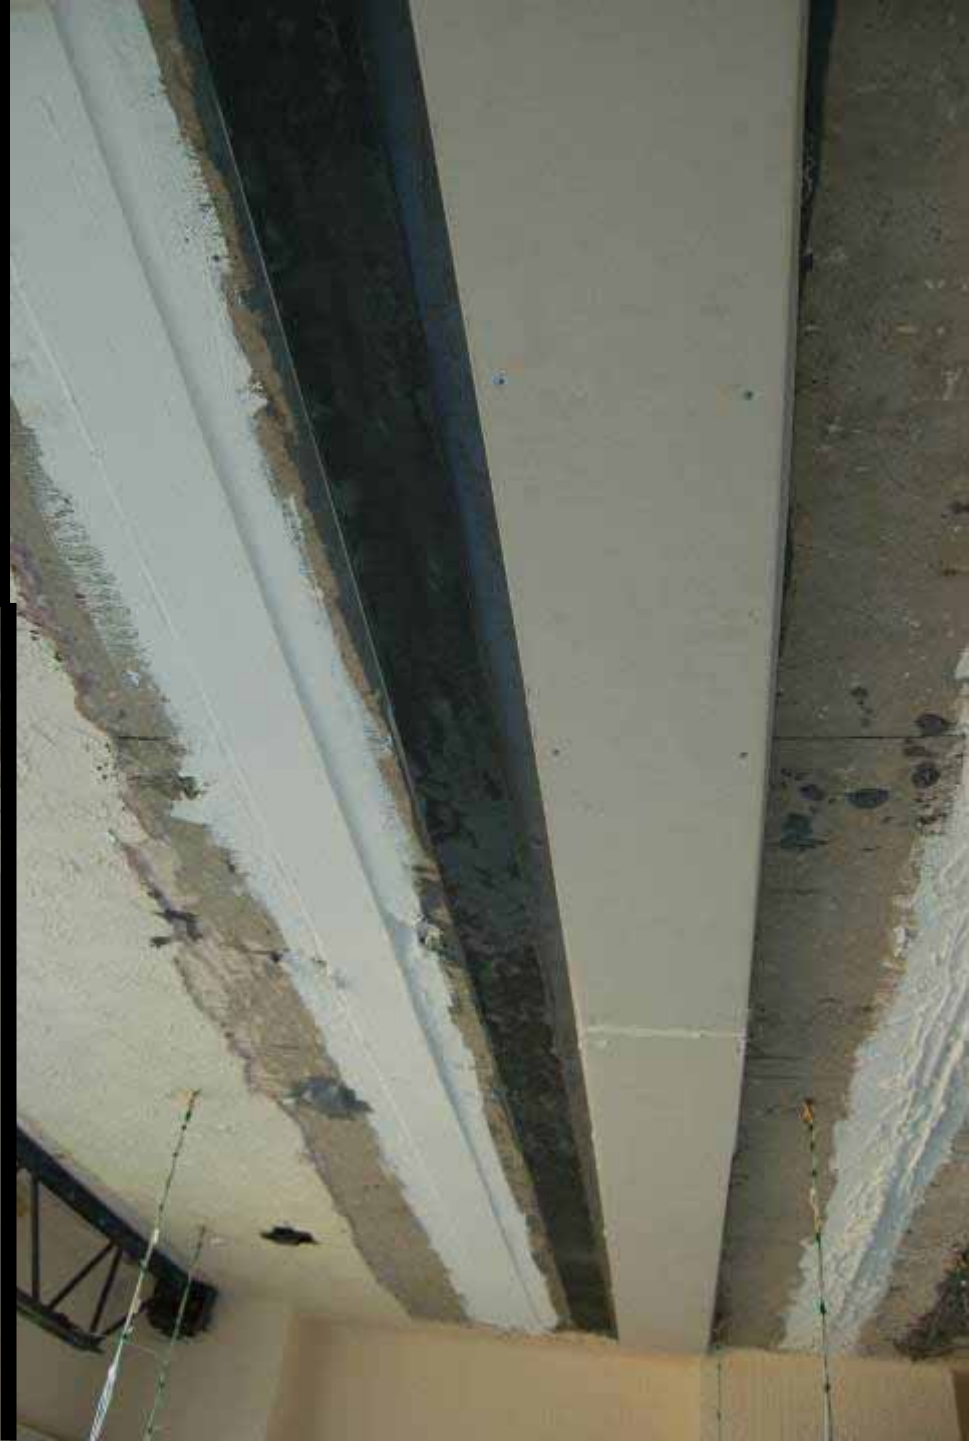
Gypsum board
2 layers of 12mm board
+ intumescent sealer
("Designed system")

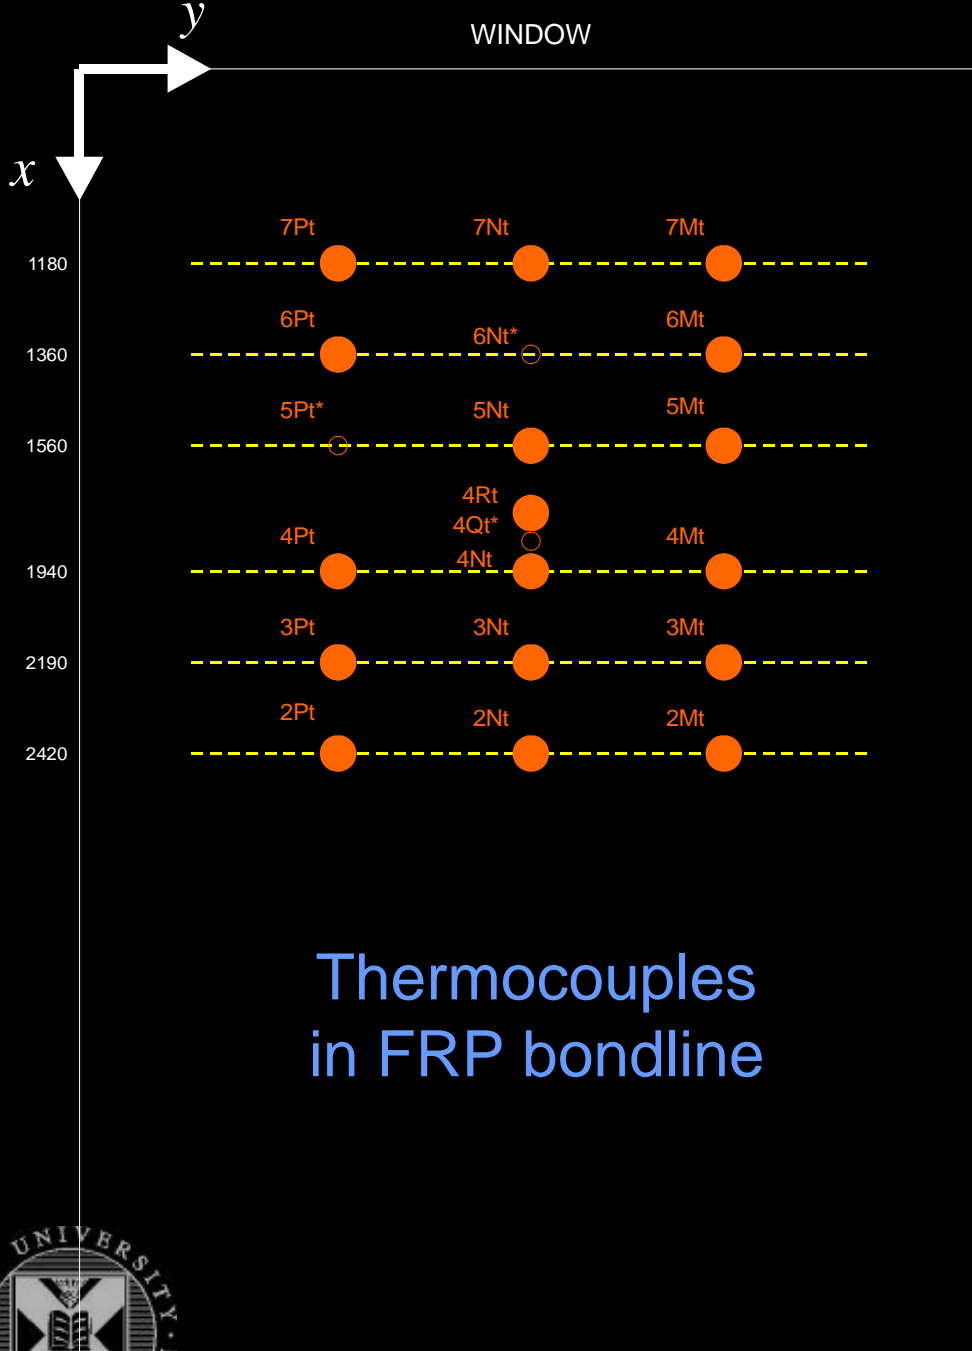
Experimental Setup

Strain gauges, Thermocouples

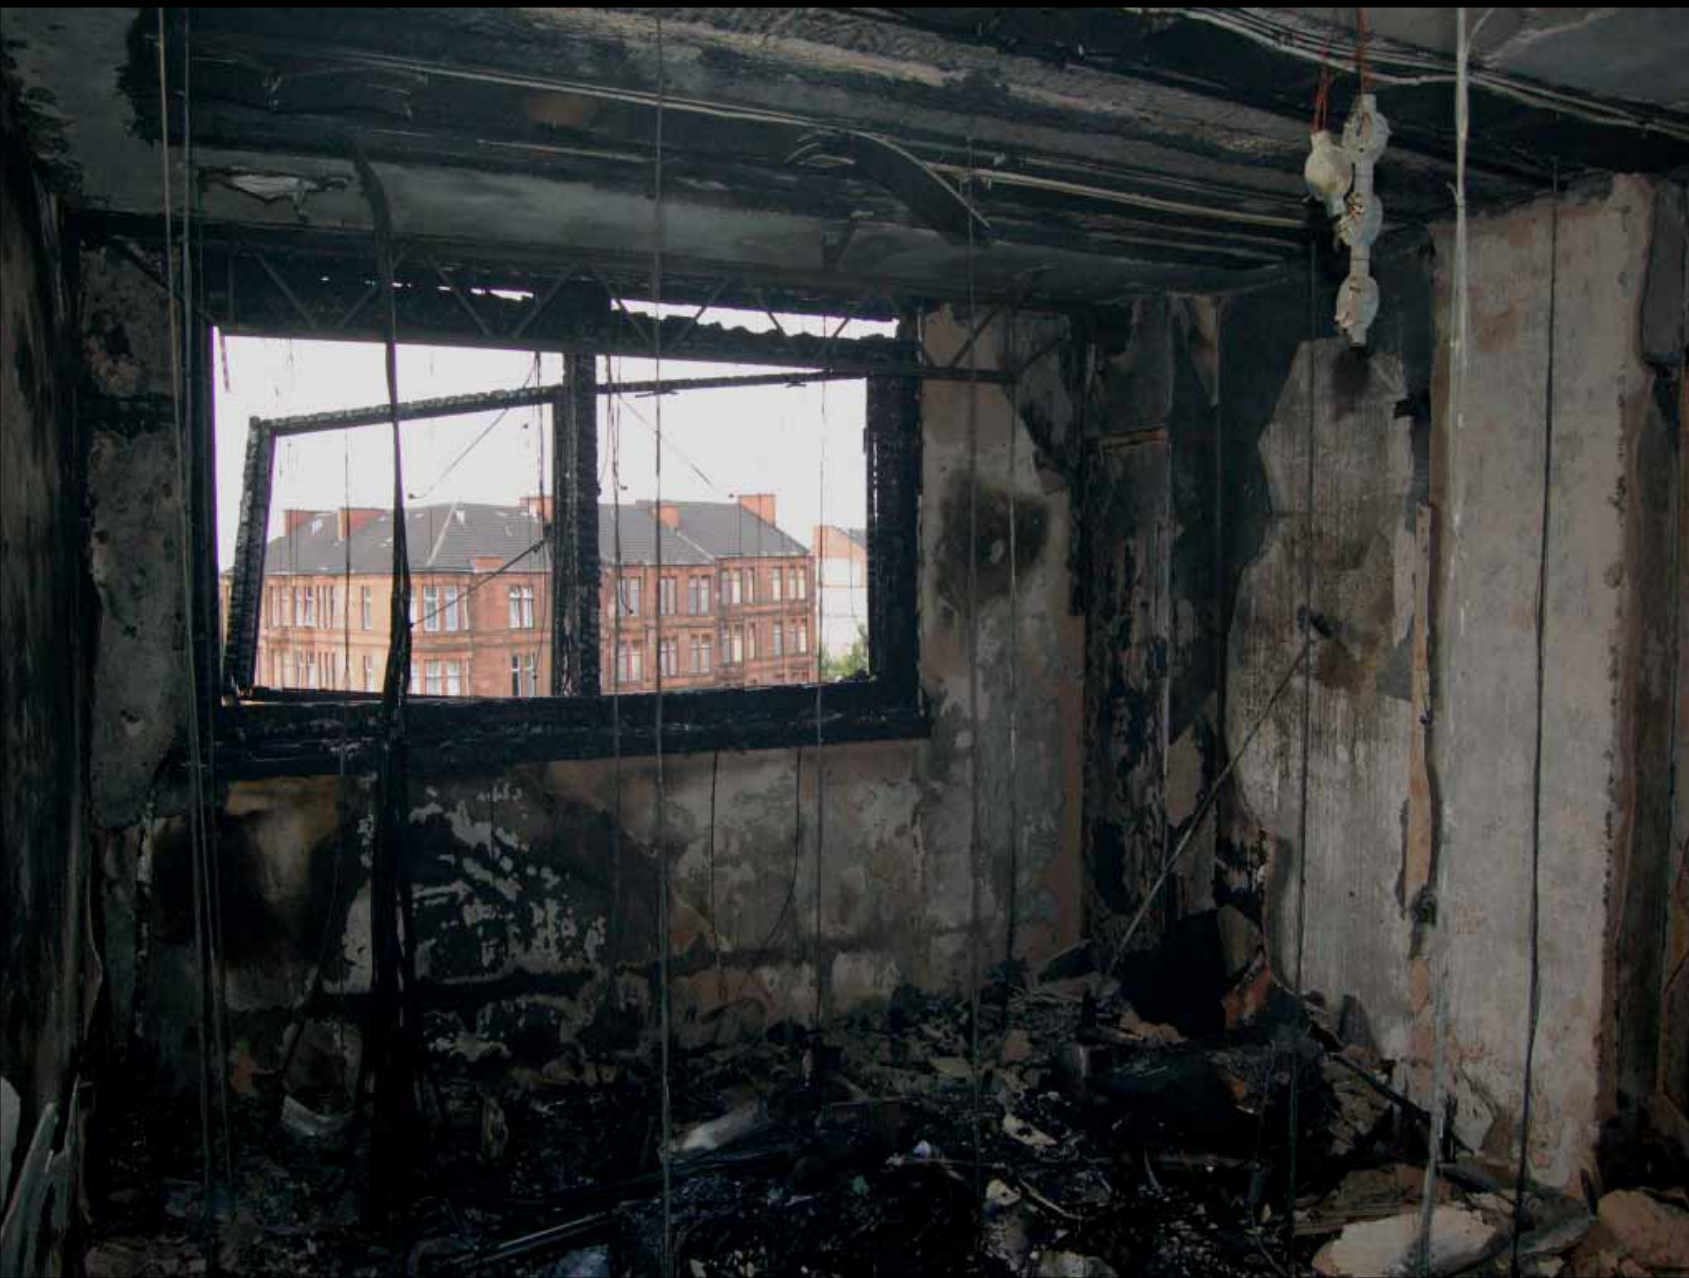
Fibres on floor (resin burnt off)

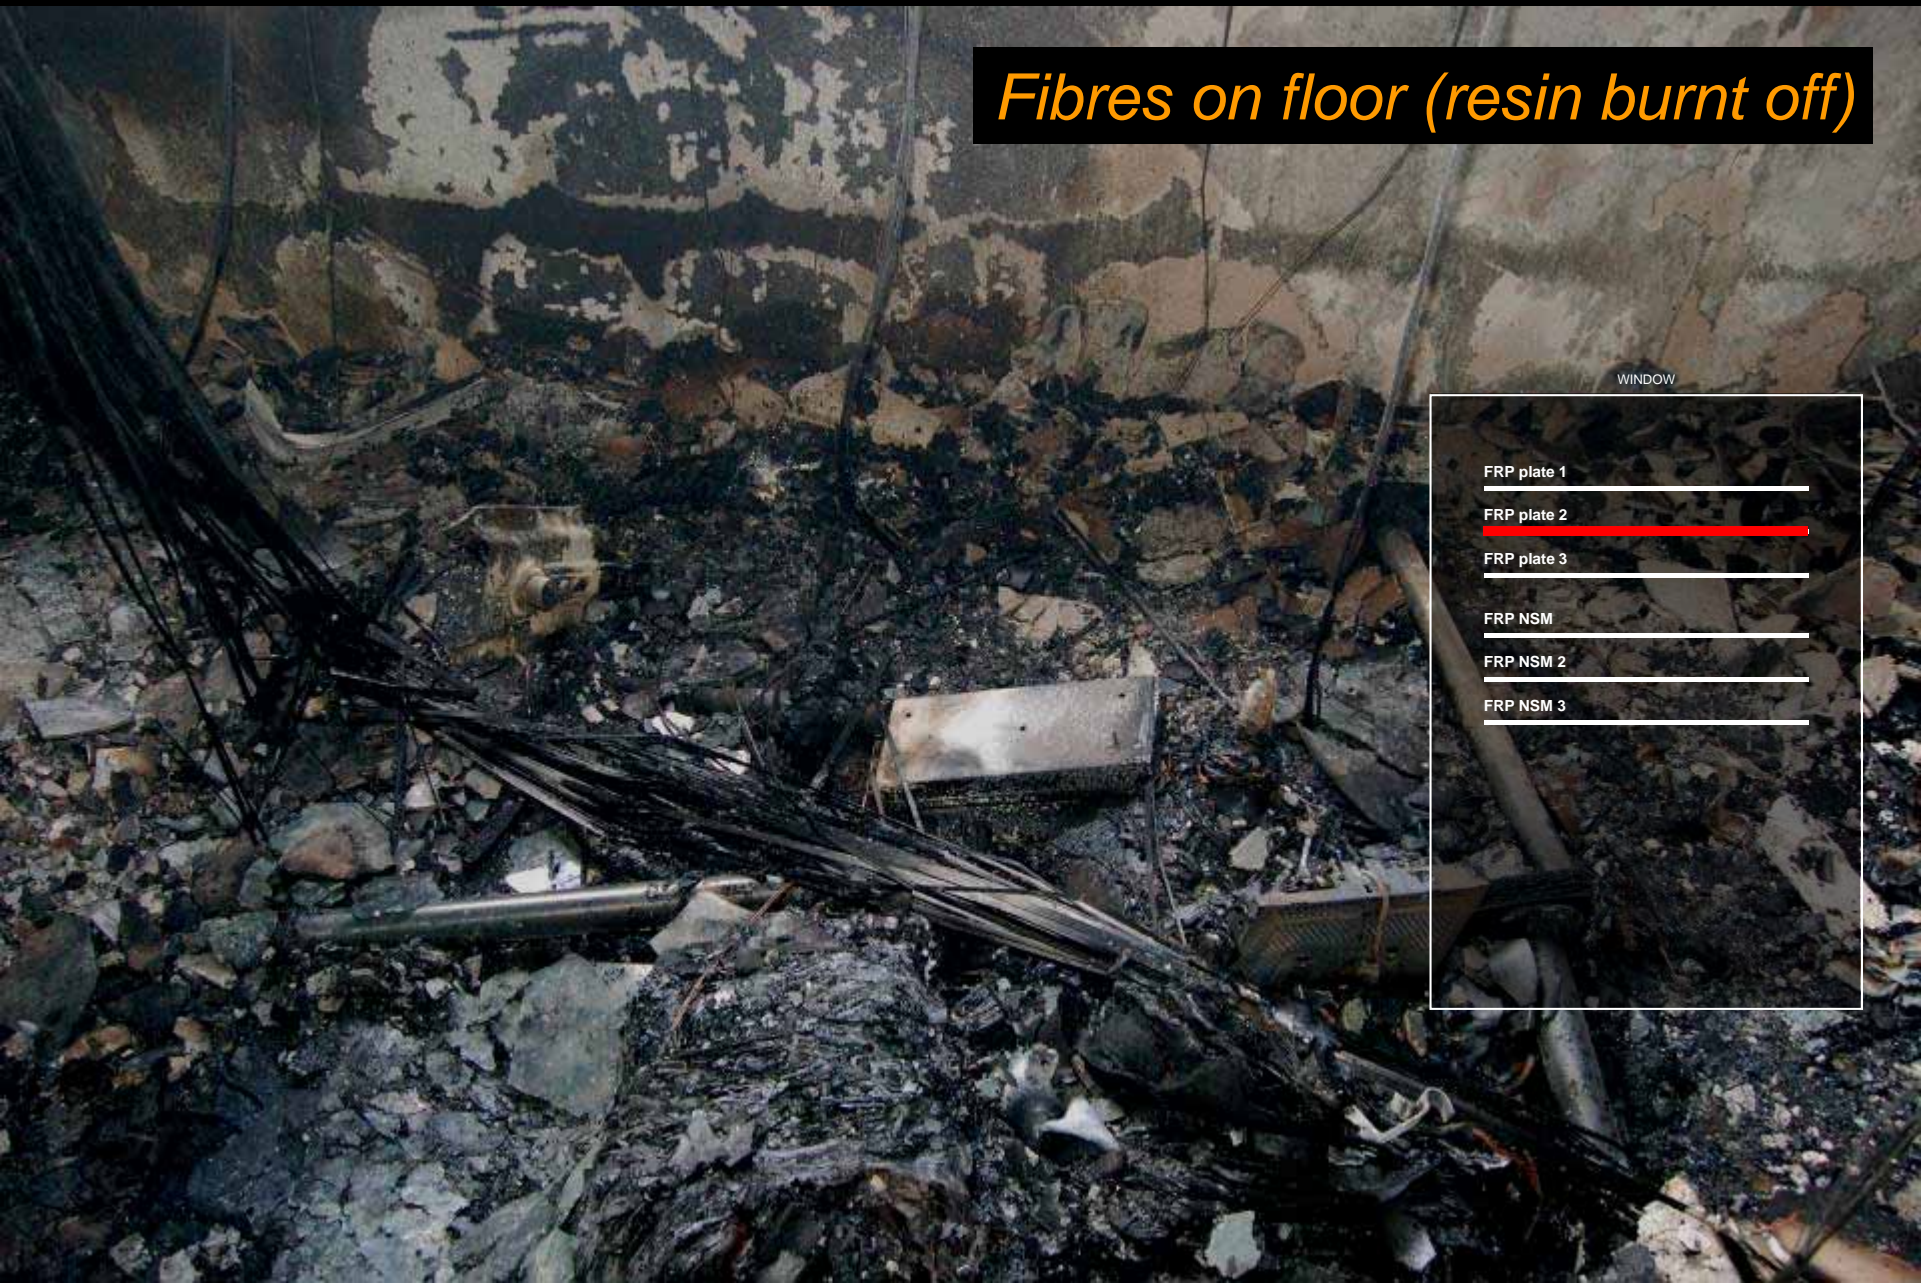
*Mostly debonded.
Resin mostly burnt off.*

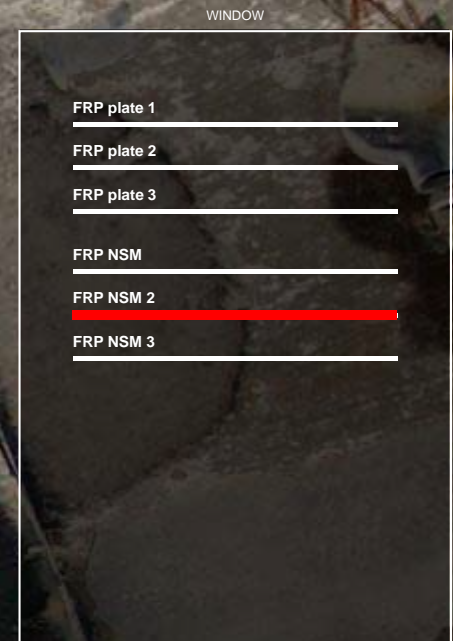
*Intumescent layer intact;
FRP and adhesive in place.*

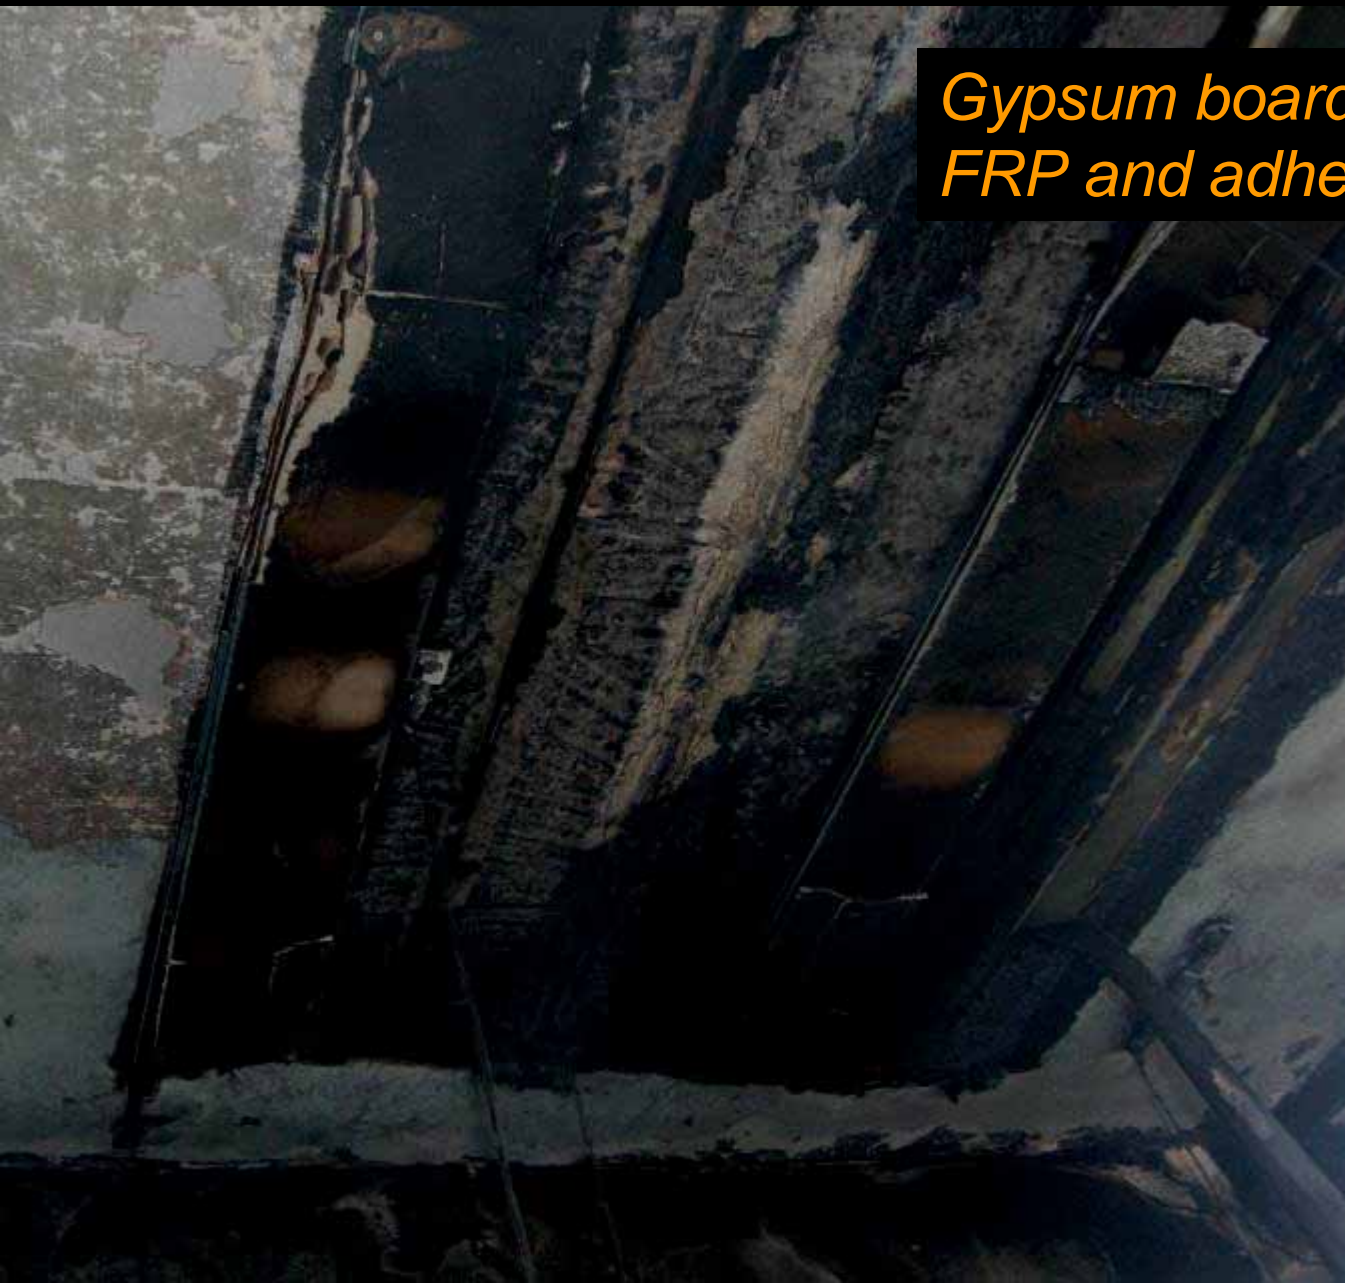
*Gypsum board sound.
FRP and adhesive visually sound.*

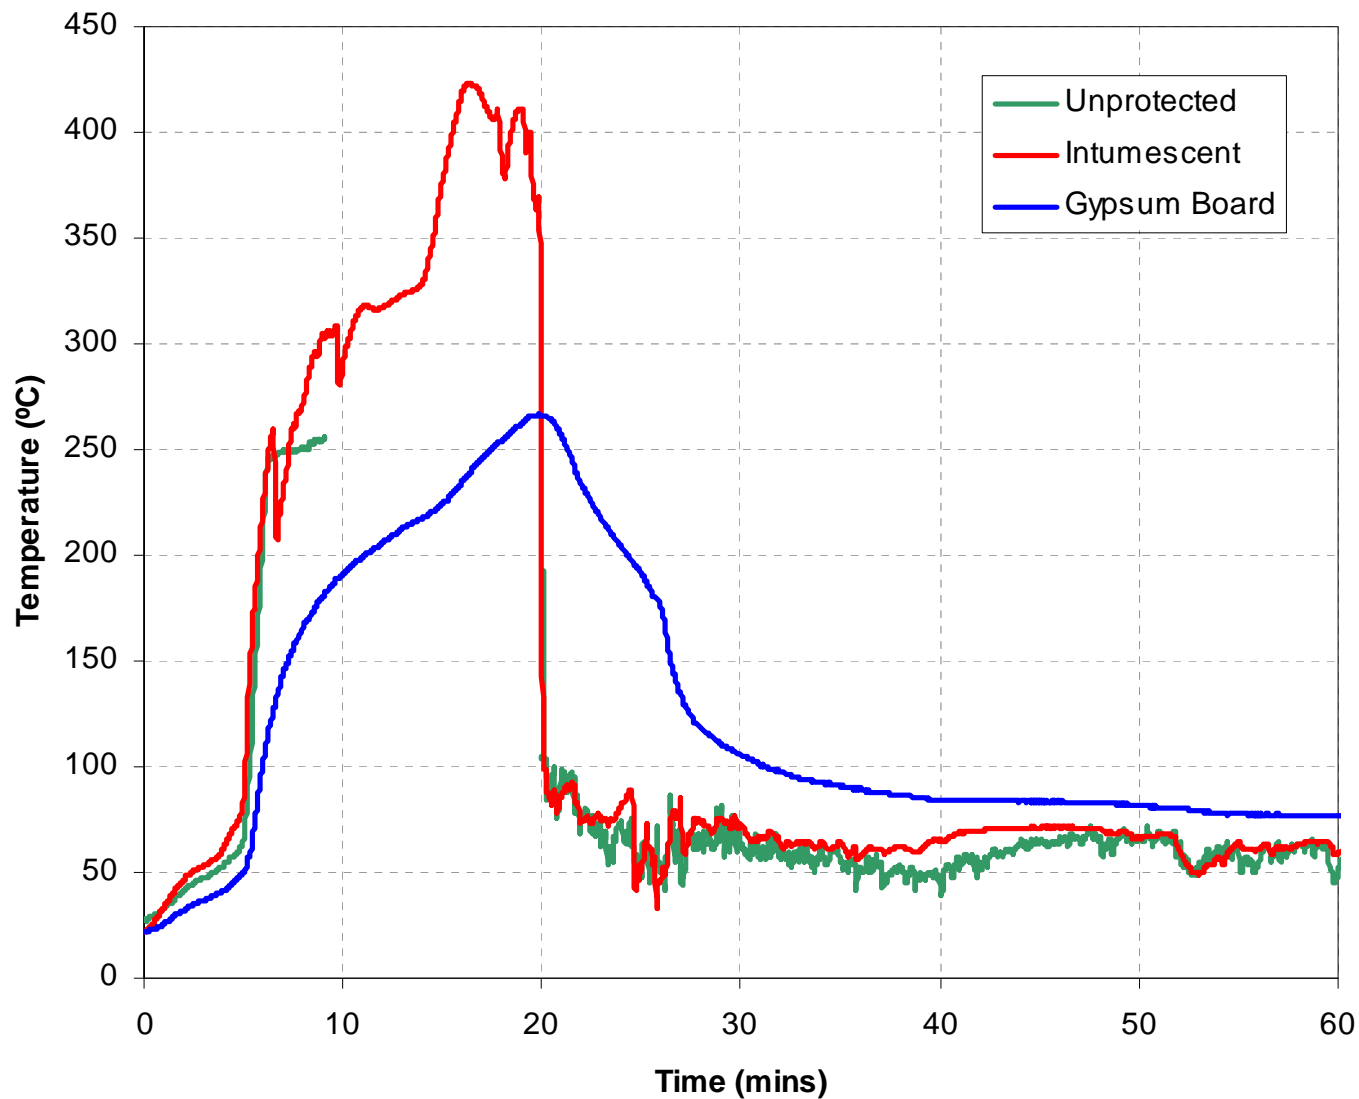
FRP Plates Bondline Temperatures

Temperatures $\gg T_g$ in all tests.

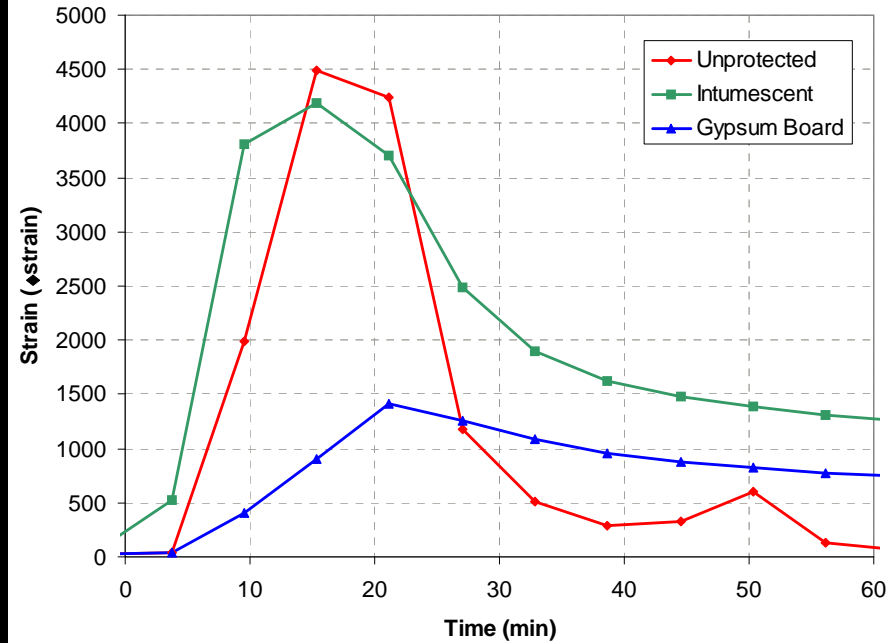
NSM Plates - Central Strain Gauge Readings

Strains \Rightarrow indication of catastrophic failure
